Project Name: Chapel Memorial Park Chapel-en-le-Frith 141020
Project Description: WinCan Import in Miraculix Standard
Project Status: Complete
Project Date: 15/10/2020
Inspection Standard: MSCC5 Sewers & Drainage GB (SRM5 Scoring)

Company: County Drains Ltd
Contact: Elspeth Holliday
Street: 49 Burlow Road
Town or City: Buxton
County: Derbyshire
Post Code: SK17 9HY
Phone: 01298 23921
Fax: 01298 23928
Email: enquiries@countydrains.com

Summary

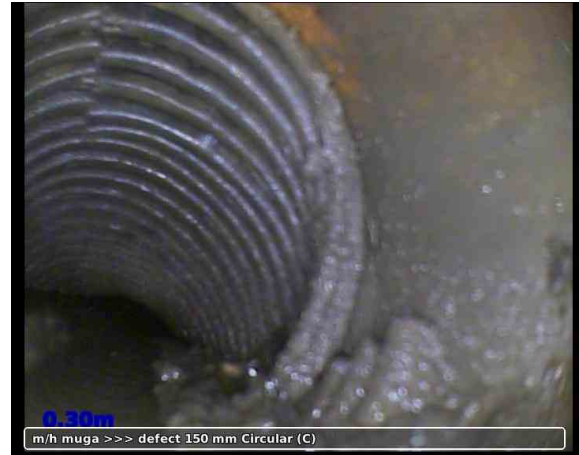
<table><tr> <td style="text-align: right;">0.00</td> <td style="text-align: center;">CP</td> <td>Start node type, catchpit, reference number: m/h muga</td> <td style="text-align: center;">00:00:07</td> <td style="text-align: center;">1</td> <td></td> <td></td> </tr><tr> <td style="text-align: right;">0.30</td> <td style="text-align: center;">MCXI</td> <td>Pipe material changes to an unidentified type of plastic at this point: Change to land drain</td> <td style="text-align: center;">00:00:44</td> <td style="text-align: center;">2</td> <td></td> <td></td> </tr></table>

2, 00:00:44, 0.30 m
 Pipe material changes to an unidentified type of plastic at this point

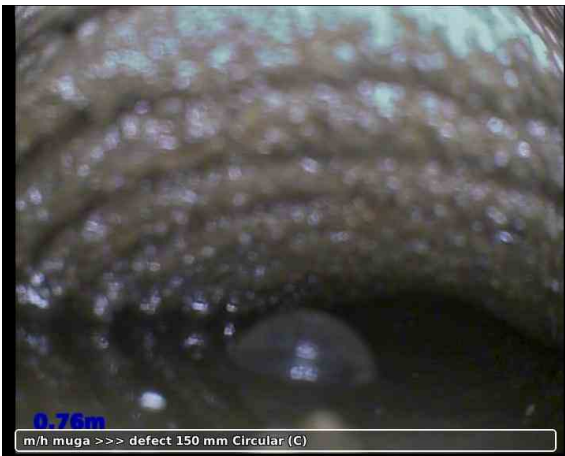
<table><tr> <td style="text-align: right;">0.00</td> <td style="text-align: center;">CP</td> <td>Start node type, catchpit, reference number: m/h muga</td> <td style="text-align: center;">00:00:07</td> <td style="text-align: center;">1</td> <td></td> <td></td> </tr><tr> <td style="text-align: right;">0.76</td> <td style="text-align: center;">WLC</td> <td>Clear water level, 90% of the vertical dimension</td> <td style="text-align: center;">00:01:24</td> <td style="text-align: center;">3</td> <td></td> <td></td> </tr></table>

3, 00:01:24, 0.76 m
 Clear water level, 90% of the vertical dimension

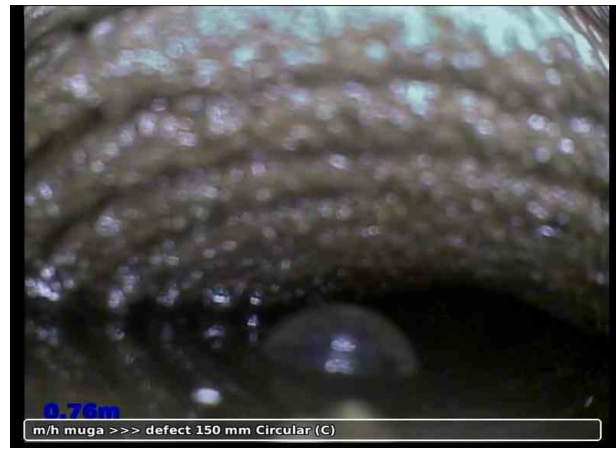
<table><tr> <td style="text-align: right;">0.00</td> <td style="text-align: center;">CP</td> <td>Start node type, catchpit, reference number: m/h muga</td> <td style="text-align: center;">00:00:07</td> <td style="text-align: center;">1</td> <td></td> <td></td> </tr><tr> <td style="text-align: right;">0.76</td> <td style="text-align: center;">D</td> <td>Deformed sewer or drain, 25%</td> <td style="text-align: center;">00:01:45</td> <td style="text-align: center;">4</td> <td></td> <td style="text-align: center;">4 / 4</td> </tr></table>

4, 00:01:45, 0.76 m
 Deformed sewer or drain, 25%

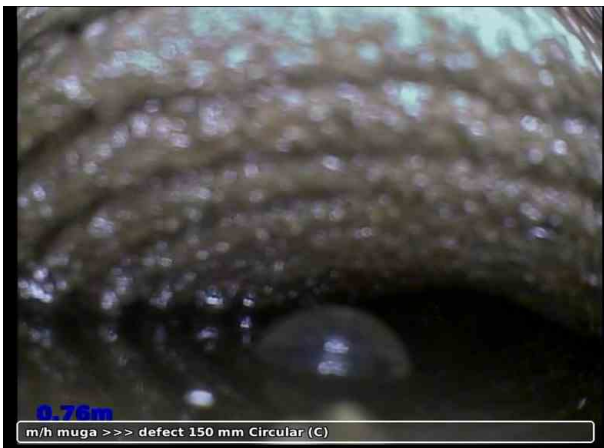
<table><tr> <td style="text-align: right;">0.00</td> <td style="text-align: center;">CP</td> <td>Start node type, catchpit, reference number: m/h muga</td> <td style="text-align: center;">00:00:07</td> <td style="text-align: center;">1</td> <td></td> <td></td> </tr><tr> <td style="text-align: right;">0.76</td> <td style="text-align: center;">SA</td> <td>Survey abandoned: No Further Access</td> <td style="text-align: center;">00:01:45</td> <td style="text-align: center;">5</td> <td></td> <td></td> </tr></table>

5, 00:01:45, 0.76 m
 Survey abandoned

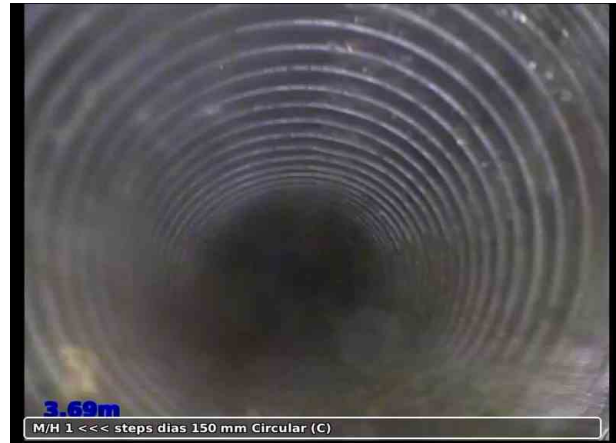
2, 00:03:36, 3.69 m
 Settled deposits, fine, 5% cross-sectional area loss, start

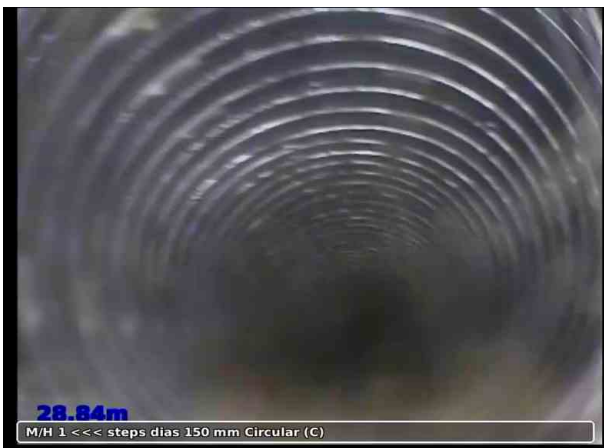
3, 00:01:30, 28.84 m
 Settled deposits, fine, 5% cross-sectional area loss, start

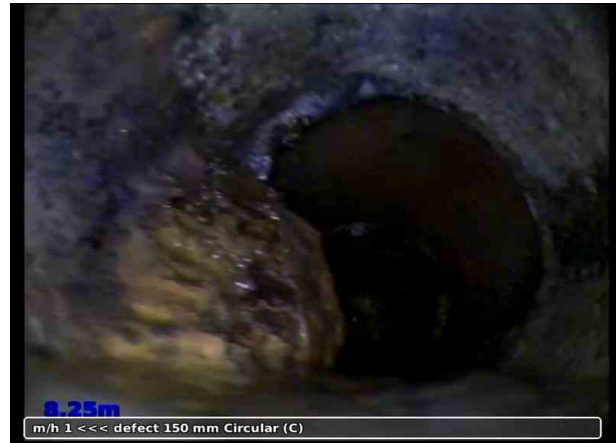
<table><tr> <td style="text-align: right;">0.00</td> <td style="text-align: center;">MH</td> <td>Start node type, manhole, reference number: 1</td> <td style="text-align: right;">00:00:04</td> <td style="text-align: center;">1</td> <td></td> <td></td> </tr><tr> <td style="text-align: right;">8.25</td> <td style="text-align: center;">DEE</td> <td>Attached deposits, encrustation from 7 o'clock to 10 o'clock, 5% cross-sectional area loss</td> <td style="text-align: right;">00:01:56</td> <td style="text-align: center;">2</td> <td style="text-align: center;">3</td> <td></td> </tr></table>

2, 00:01:56, 8.25 m
 Attached deposits, encrustation from 7 o'clock to 10 o'clock,
 5% cross-sectional area loss

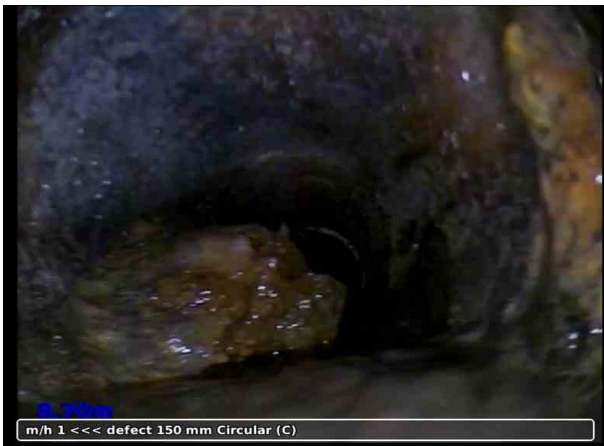
<table><tr> <td style="text-align: right;">0.00</td> <td style="text-align: center;">MH</td> <td>Start node type, manhole, reference number: 1</td> <td style="text-align: right;">00:00:04</td> <td style="text-align: center;">1</td> <td></td> <td></td> </tr><tr> <td style="text-align: right;">8.70</td> <td style="text-align: center;">DEE</td> <td>Attached deposits, encrustation from 7 o'clock to 9 o'clock, 20% cross-sectional area loss</td> <td style="text-align: right;">00:01:47</td> <td style="text-align: center;">3</td> <td style="text-align: center;">3</td> <td></td> </tr></table>

3, 00:01:47, 8.70 m
 Attached deposits, encrustation from 7 o'clock to 9 o'clock,
 20% cross-sectional area loss

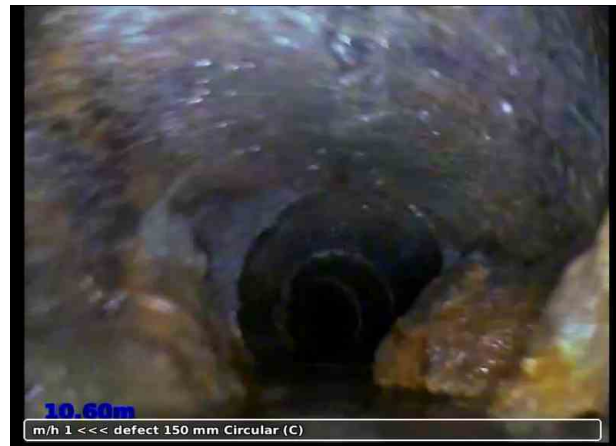
<table><tr> <td style="text-align: right;">0.00</td> <td style="text-align: center;">MH</td> <td>Start node type, manhole, reference number: 1</td> <td style="text-align: right;">00:00:04</td> <td style="text-align: center;">1</td> <td></td> <td></td> </tr><tr> <td style="text-align: right;">10.64</td> <td style="text-align: center;">DEE</td> <td>Attached deposits, encrustation from 3 o'clock to 7 o'clock, 15% cross-sectional area loss</td> <td style="text-align: right;">00:01:34</td> <td style="text-align: center;">4</td> <td style="text-align: center;">3</td> <td></td> </tr></table>

4, 00:01:34, 10.64 m
 Attached deposits, encrustation from 3 o'clock to 7 o'clock,
 15% cross-sectional area loss

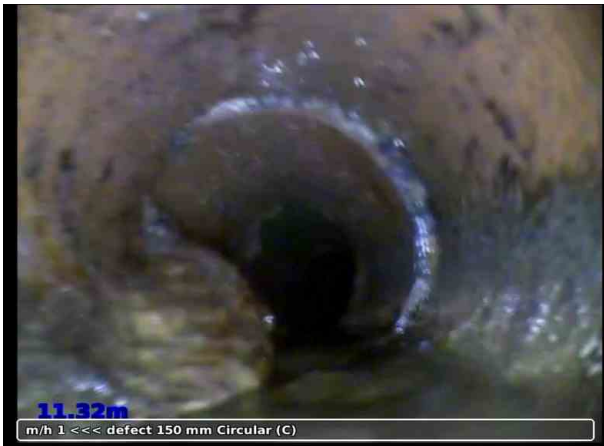
<table><tr> <td style="text-align: right;">0.00</td> <td style="text-align: center;">MH</td> <td>Start node type, manhole, reference number: 1</td> <td style="text-align: right;">00:00:04</td> <td style="text-align: center;">1</td> <td></td> <td></td> </tr><tr> <td style="text-align: right;">11.40</td> <td style="text-align: center;">DEE</td> <td>Attached deposits, encrustation from 7 o'clock to 9 o'clock, 10% cross-sectional area loss</td> <td style="text-align: right;">00:01:31</td> <td style="text-align: center;">5</td> <td style="text-align: center;">3</td> <td></td> </tr></table>

5, 00:01:31, 11.40 m
 Attached deposits, encrustation from 7 o'clock to 9 o'clock,
 10% cross-sectional area loss

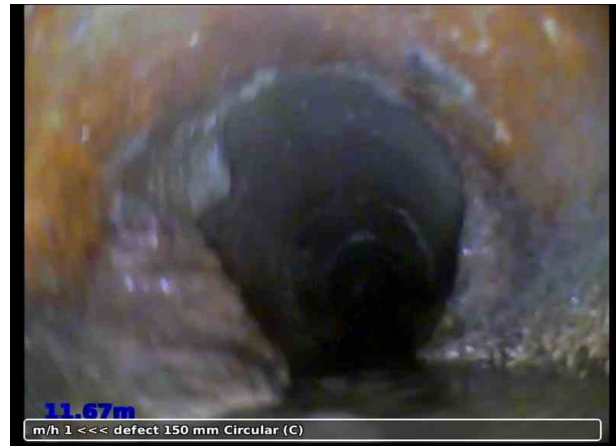
<table><tr> <td style="text-align: right;">0.00</td> <td style="text-align: center;">MH</td> <td>Start node type, manhole, reference number: 1</td> <td style="text-align: right;">00:00:04</td> <td style="text-align: center;">1</td> <td></td> <td></td> </tr><tr> <td style="text-align: right;">11.70</td> <td style="text-align: center;">DEE</td> <td>Attached deposits, encrustation from 6 o'clock to 9 o'clock, 10% cross-sectional area loss</td> <td style="text-align: right;">00:01:28</td> <td style="text-align: center;">6</td> <td style="text-align: center;">3</td> <td></td> </tr></table>

6, 00:01:28, 11.70 m
 Attached deposits, encrustation from 6 o'clock to 9 o'clock,
 10% cross-sectional area loss

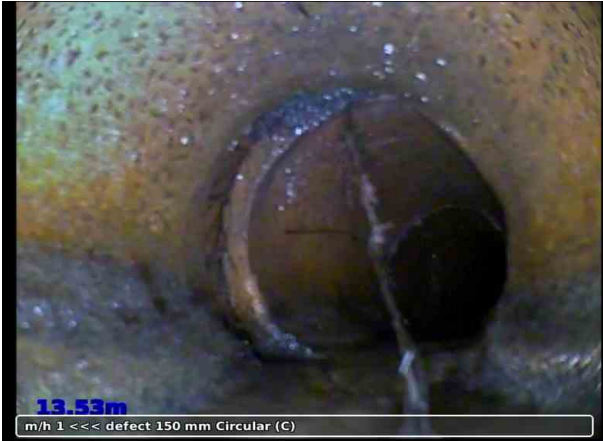
<table><tr> <td style="text-align: right;">0.00</td> <td style="text-align: center;">MH</td> <td>Start node type, manhole, reference number: 1</td> <td style="text-align: right;">00:00:04</td> <td style="text-align: center;">1</td> <td></td> <td></td> </tr><tr> <td style="text-align: right;">13.53</td> <td style="text-align: center;">LR</td> <td>Line deviates right</td> <td style="text-align: right;">00:01:17</td> <td style="text-align: center;">7</td> <td></td> <td></td> </tr></table>

7, 00:01:17, 13.53 m
Line deviates right

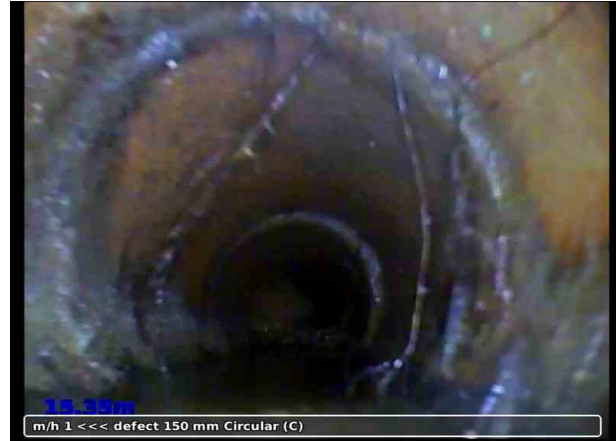
<table><tr> <td style="text-align: right;">0.00</td> <td style="text-align: center;">MH</td> <td>Start node type, manhole, reference number: 1</td> <td style="text-align: right;">00:00:04</td> <td style="text-align: center;">1</td> <td></td> <td></td> </tr><tr> <td style="text-align: right;">15.36</td> <td style="text-align: center;">RF</td> <td>Roots, fine</td> <td style="text-align: right;">00:01:08</td> <td style="text-align: center;">8</td> <td style="text-align: center;">2</td> <td></td> </tr></table>

8, 00:01:08, 15.36 m
Roots, fine

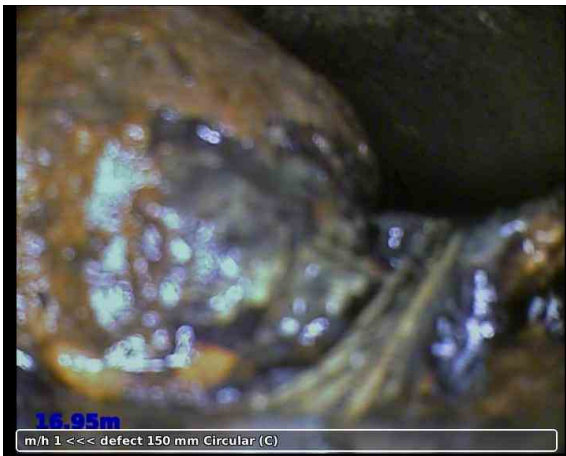
<table><tr> <td style="text-align: right;">0.00</td> <td style="text-align: center;">MH</td> <td>Start node type, manhole, reference number: 1</td> <td style="text-align: right;">00:00:04</td> <td style="text-align: center;">1</td> <td></td> <td></td> </tr><tr> <td style="text-align: right;">16.95</td> <td style="text-align: center;">OBX</td> <td>Other obstacles, other object in invert from 5 o'clock to 9 o'clock, 30% cross-sectional area loss: Unknown Obstruction</td> <td style="text-align: right;">00:00:25</td> <td style="text-align: center;">9</td> <td style="text-align: center;">5</td> <td></td> </tr></table>

9, 00:00:25, 16.95 m
Other obstacles, other object in invert from 5 o'clock to 9 o'clock, 30% cross-sectional area loss

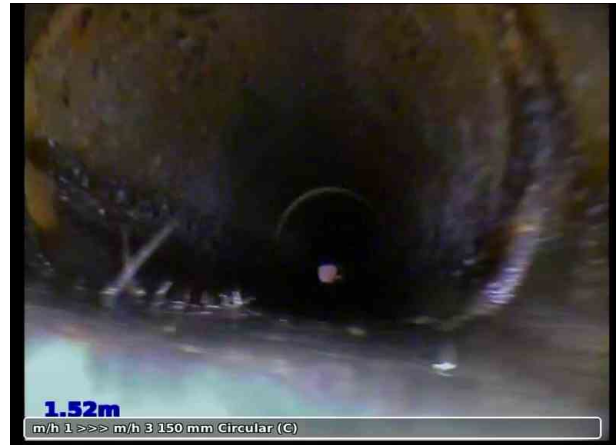
2, 00:00:40, 1.52 m
 Roots, fine

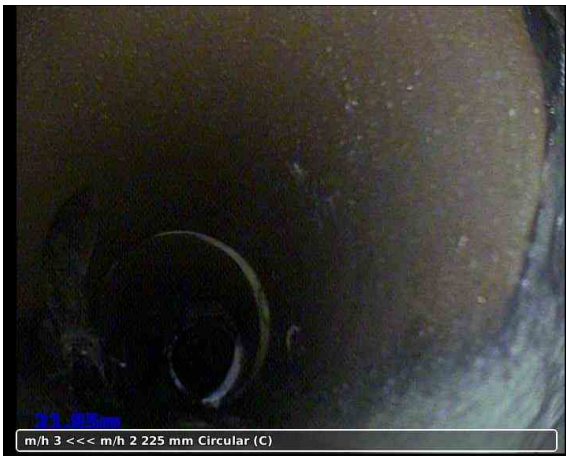
3, 00:00:48, 21.85 m
 Connection other than junction, at 09 o'clock, diameter: 100 mm

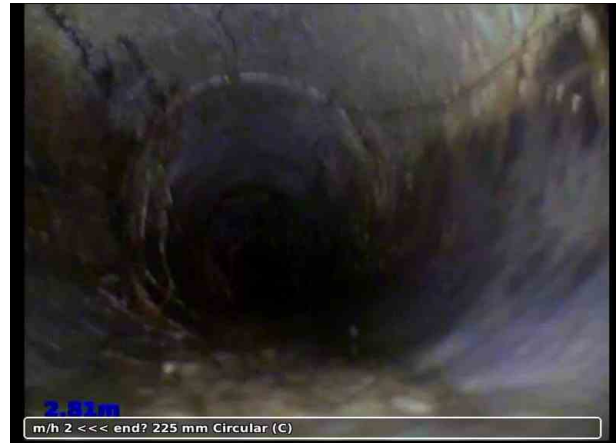
2, 00:02:19, 2.85 m
 Roots, fine at joint

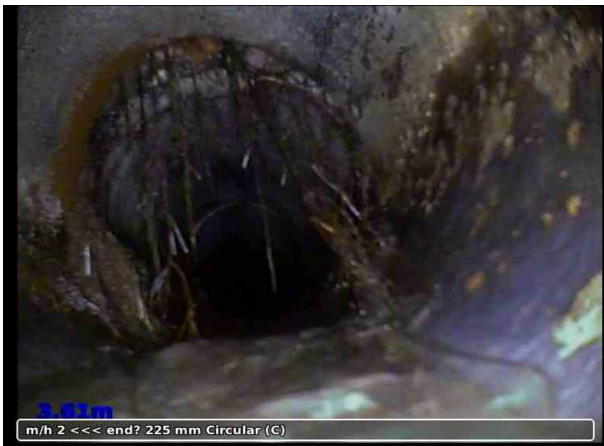
3, 00:02:13, 3.61 m
 Roots, fine at joint

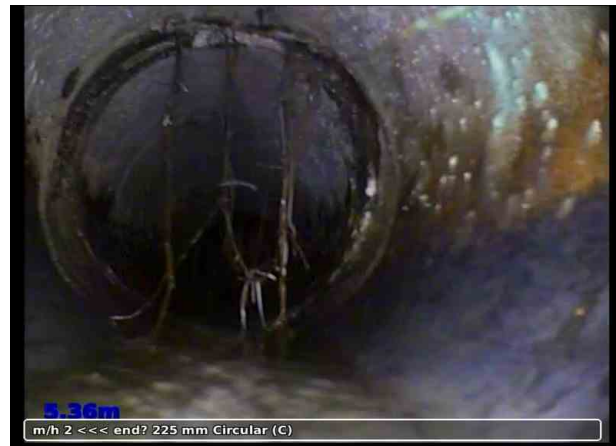
4, 00:02:07, 5.36 m
 Roots, fine at joint

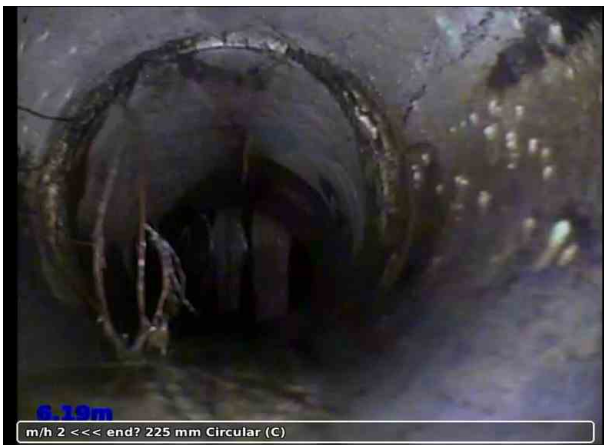
5, 00:02:04, 6.19 m
 Roots, fine at joint

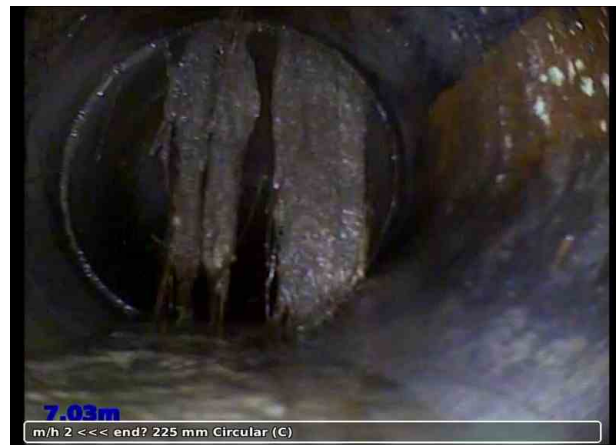
6, 00:02:01, 7.03 m
 Roots, mass at joint, 25% cross-sectional area loss

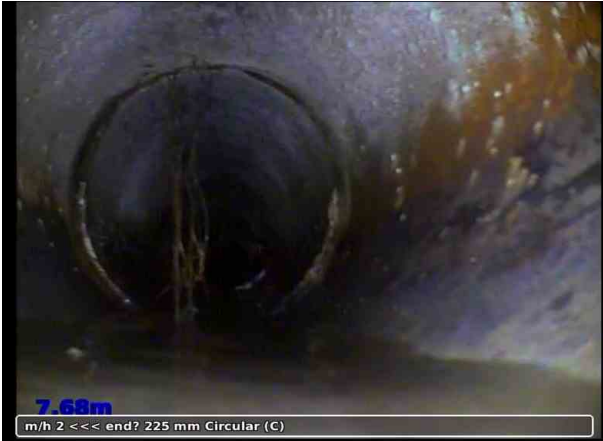
7, 00:01:55, 7.68 m
 Roots, fine at joint

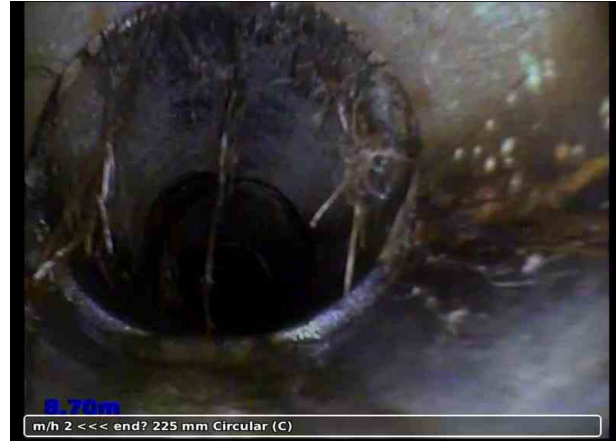
8, 00:01:47, 8.70 m
 Roots, fine at joint

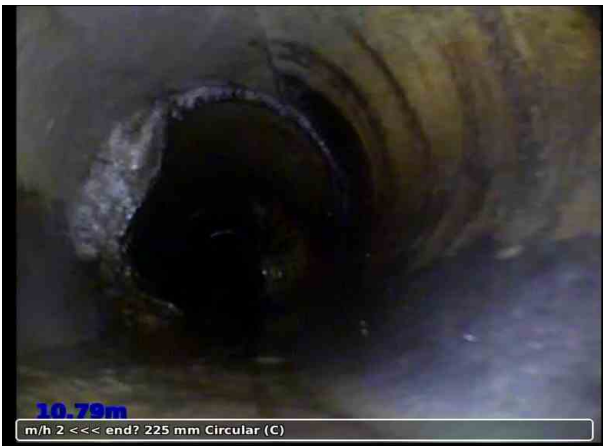
9, 00:01:38, 10.87 m
 Attached deposits, encrustation from 8 o'clock to 11 o'clock,
 5% cross-sectional area loss

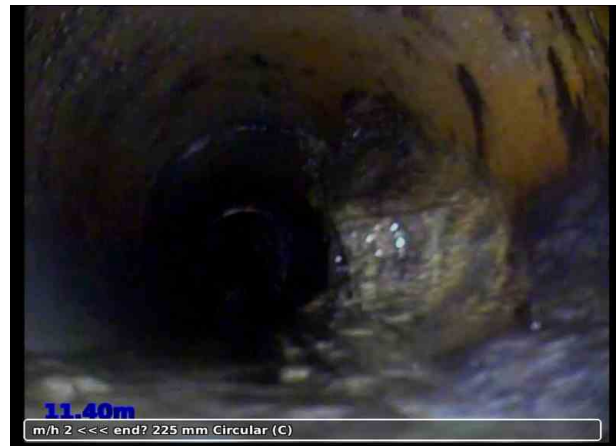
10, 00:01:34, 11.44 m
 Attached deposits, encrustation from 2 o'clock to 5 o'clock,
 10% cross-sectional area loss

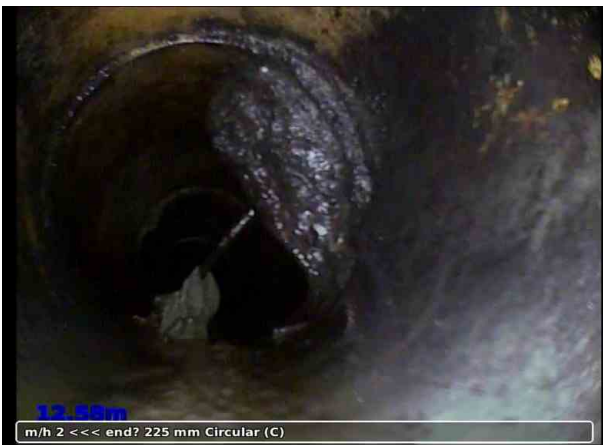
11, 00:01:29, 12.58 m
 Attached deposits, encrustation from 1 o'clock to 5 o'clock,
 10% cross-sectional area loss

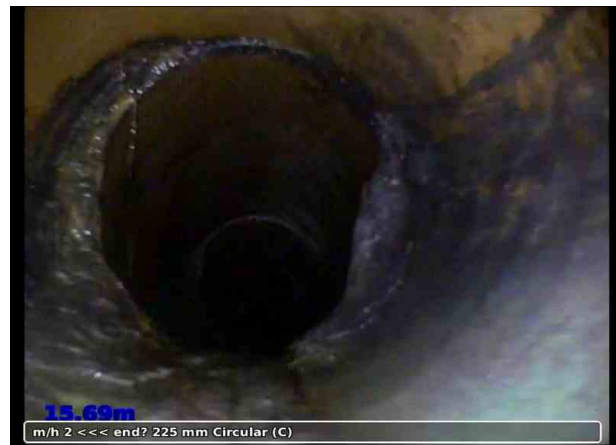
12, 00:01:04, 15.69 m
 Attached deposits, encrustation from 2 o'clock to 11 o'clock,
 5% cross-sectional area loss

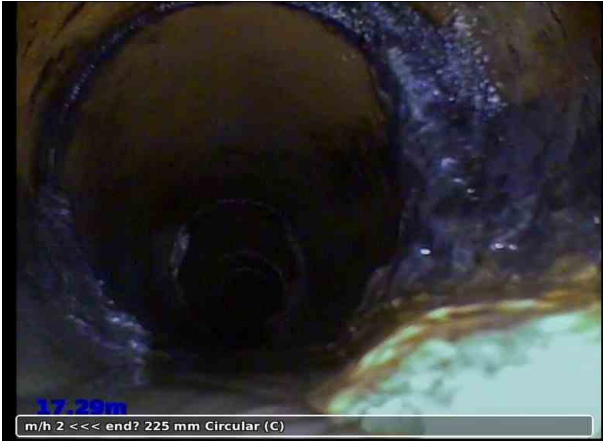
13, 00:00:56, 17.29 m
 Attached deposits, encrustation from 4 o'clock to 6 o'clock, 5% cross-sectional area loss

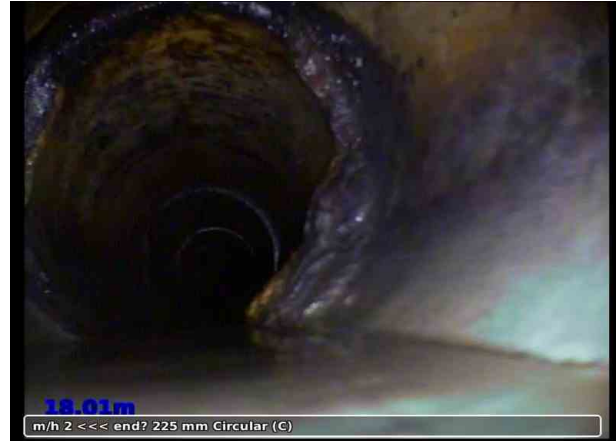
18.05	DEE	Attached deposits, encrustation from 3 o'clock to 5 o'clock, 5% cross-sectional area loss	00:00:46	14	3

14, 00:00:46, 18.05 m
 Attached deposits, encrustation from 3 o'clock to 5 o'clock, 5% cross-sectional area loss

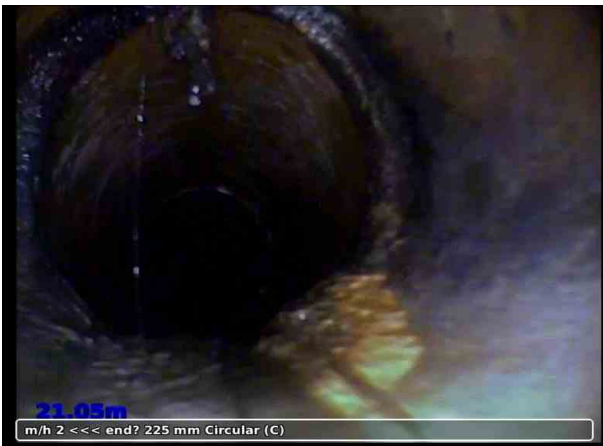
15, 00:00:34, 21.13 m
 Attached deposits, encrustation at 5 o'clock, 5% cross-sectional area loss

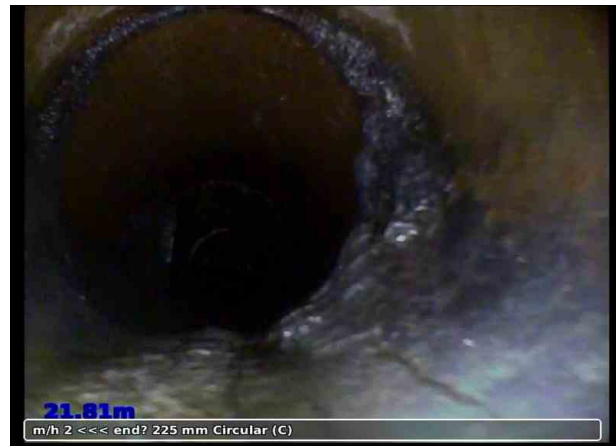
16, 00:00:30, 21.81 m
 Attached deposits, encrustation from 2 o'clock to 6 o'clock, 5% cross-sectional area loss

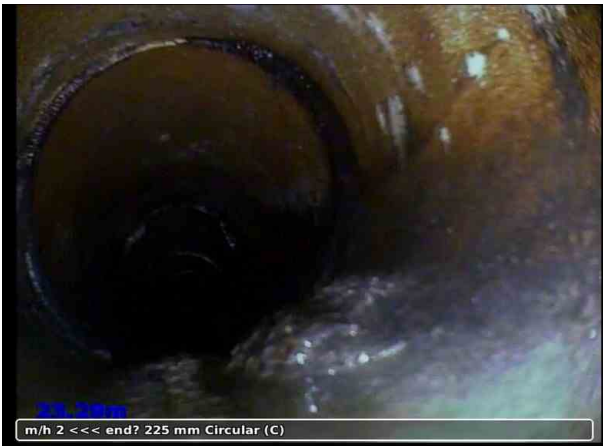
17, 00:00:24, 23.29 m
 Attached deposits, encrustation from 4 o'clock to 6 o'clock, 5% cross-sectional area loss

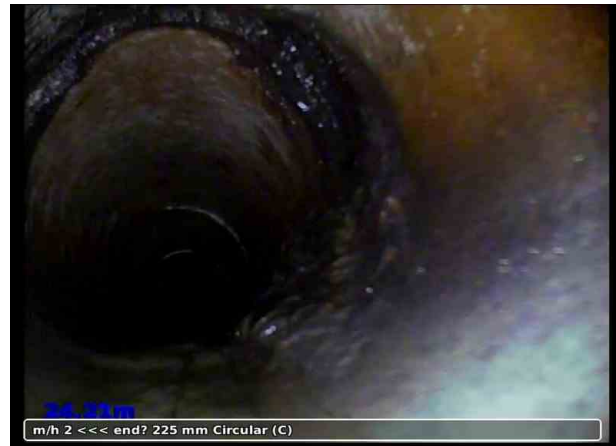
18, 00:00:20, 24.21 m
 Attached deposits, encrustation from 4 o'clock to 5 o'clock, 5% cross-sectional area loss

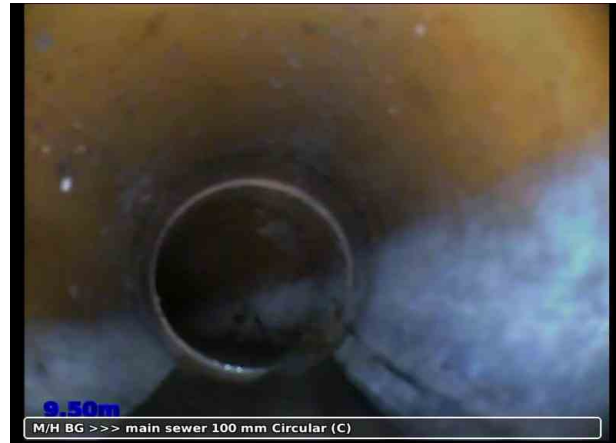
2, 00:01:00, 9.54 m
 Line deviates left

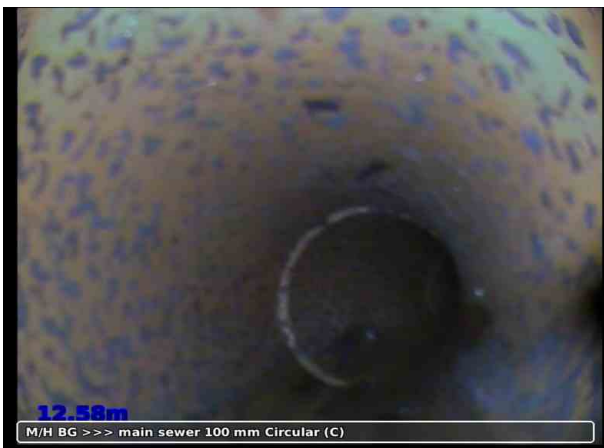
3, 00:00:41, 12.58 m
 Line deviates right
